# Ares I-X 30 Day Report

*December 3, 2009*

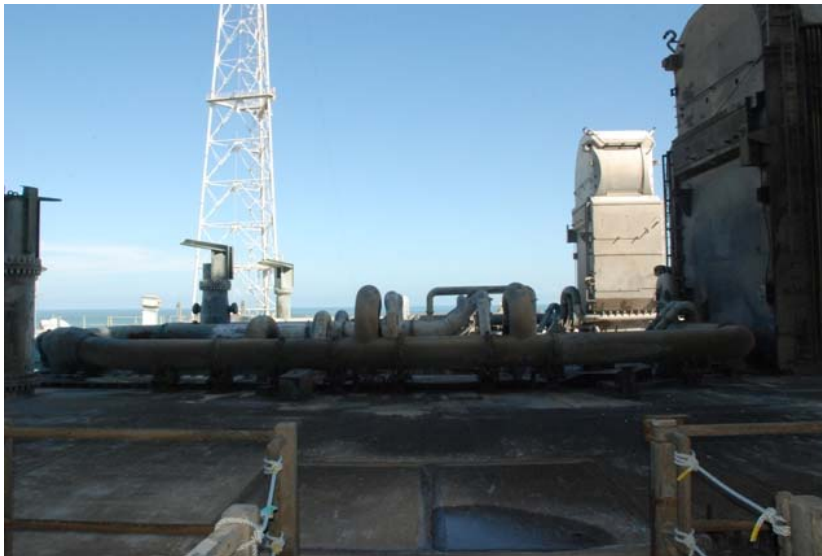
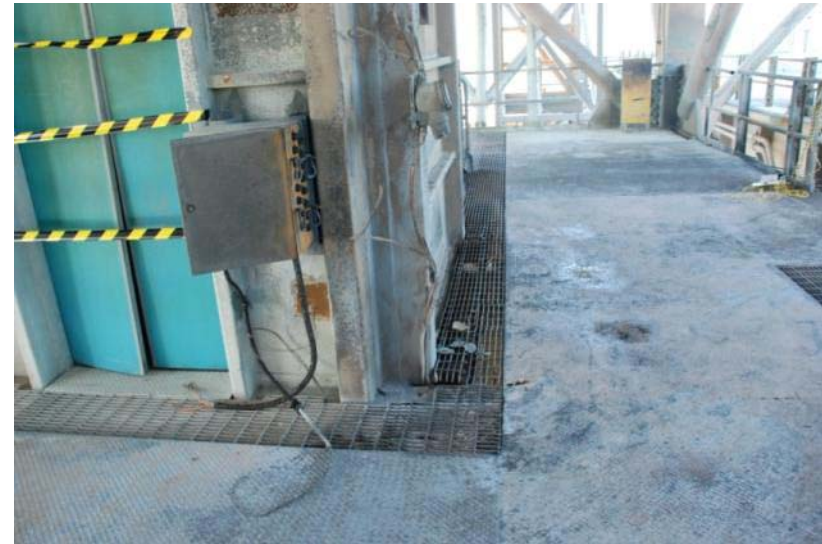
◆ **Also experienced some damage in the flame trench to the fondue fire.**

- West side wall had some damage on the flame fence wall. No obvious brick damage was observed.
- East wall damage was near a suspect location identified in the pre-launch inspection.

- ◆ PAD designers were very satisfied with results
- ◆ This flight will help Ares I structures designers as they design for an Ares I FAM

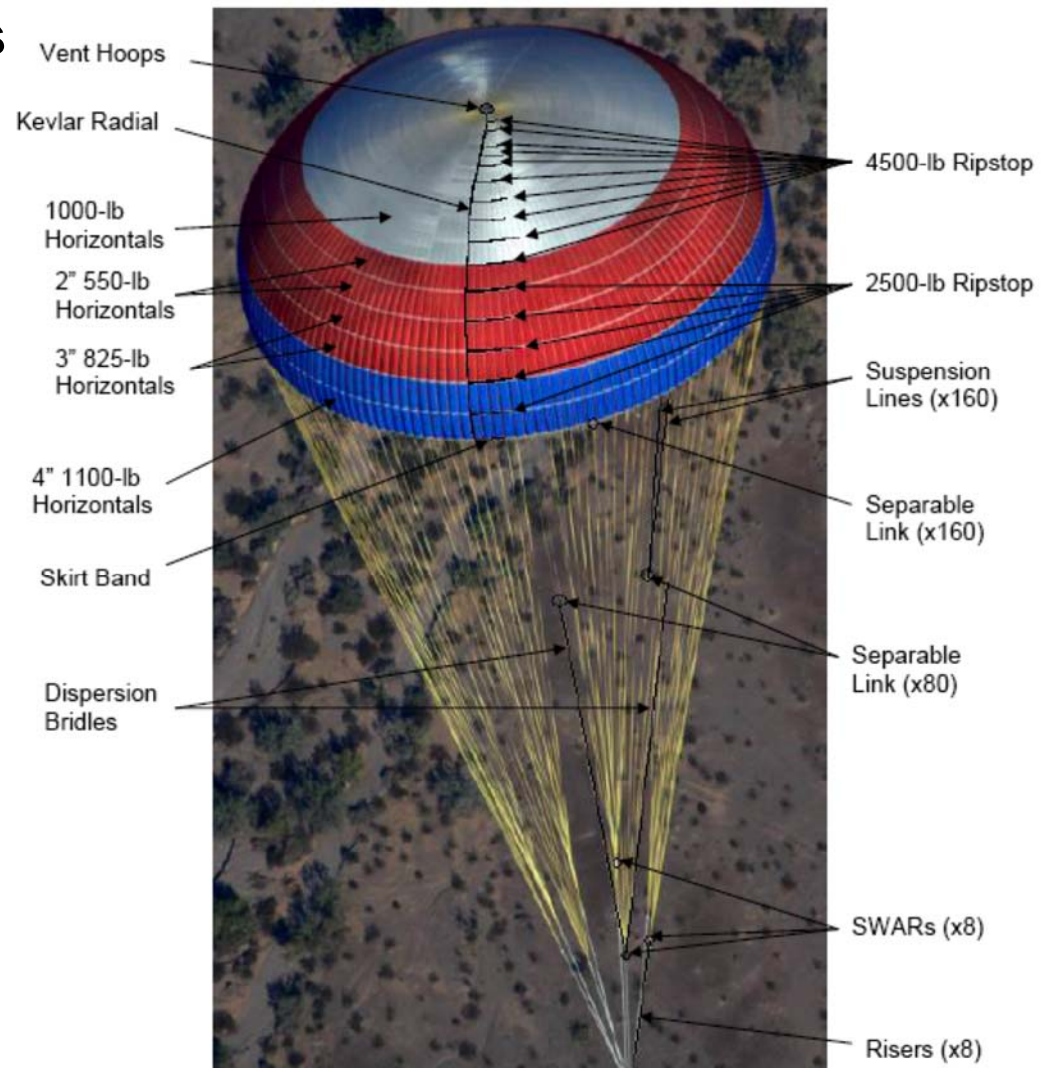
Major Components in a Main Parachute

- ◆ One of the main parachutes failed at initial inflation
- ◆ 1<sup>st</sup> parachute may have “dis-reefed” prematurely allowing parachute to inflate too quickly
  - Increased initial load on parachute and riser line system
  - Salt Water Activation Release (SWAR) hardware exhibits damage representative of an overload
- ◆ A second parachute then partially failed
  - Assessment underway
